Case 249 : Narrative

Case Vehicle (A): 1999 Jeep	Veh. (B): 1998 Ford
Type: Grand Cherokee Laredo, 4 x 4, 4-door SUV	Type: Escort Sport SE, 4-door sedan
Driver: 50- year-old male	Driver: 33- year-old female
CDC: 12-FYEW-2	CDC: 01-FDEW-2

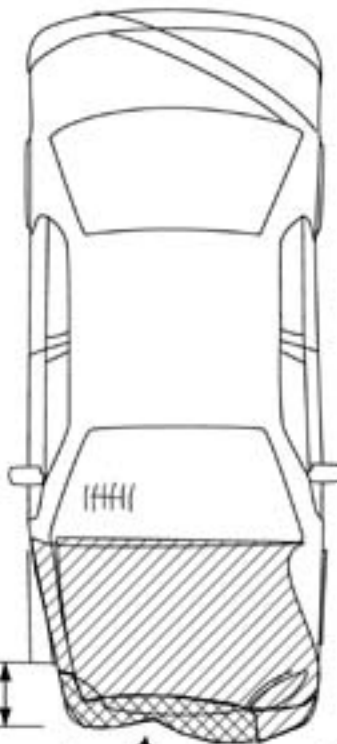
POST-CRASH
Bumper corner Stringline 70 248 12 Bumper corner Stringline 90 105

34

Max. crush to front
right bumper
